ESTCP Cost and Performance Report

(ER-200519)

Field Demonstration/Validation of Electrolytic Reactive Barriers for Energetic Compounds at Pueblo Chemical Depot

July 2010

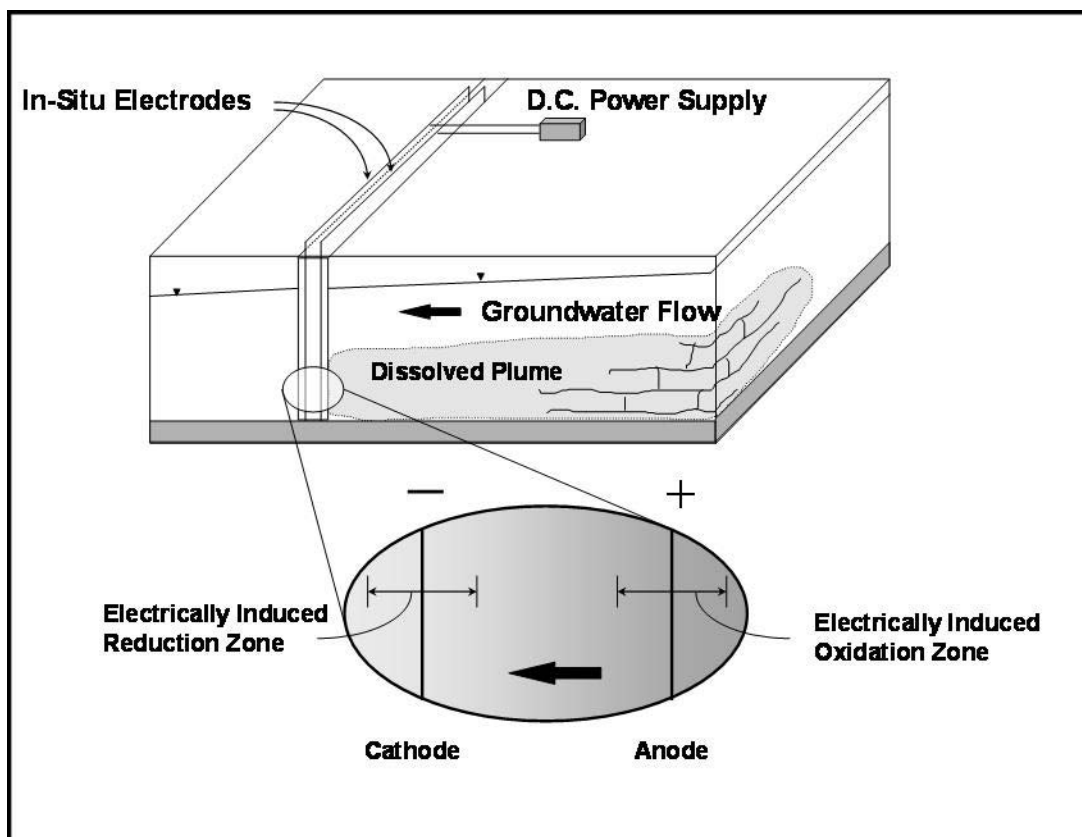
Figure 1. Conceptualization of a field-scale e⁻barrier.

The e⁻barrier consists of a panel of closely spaced permeable electrodes, which is installed beneath the ground's surface, intercepting a plume of contaminated groundwater. Applying electrical potential to the electrodes imposes oxidizing conditions at the positive electrodes and reducing conditions at the negative electrodes. By imposing sequential oxidizing and reducing conditions, thermodynamic conditions are shifted to drive the transformation of target compounds to nontoxic products. A field-scale conceptualization of an e⁻barrier is illustrated in Figure 1.

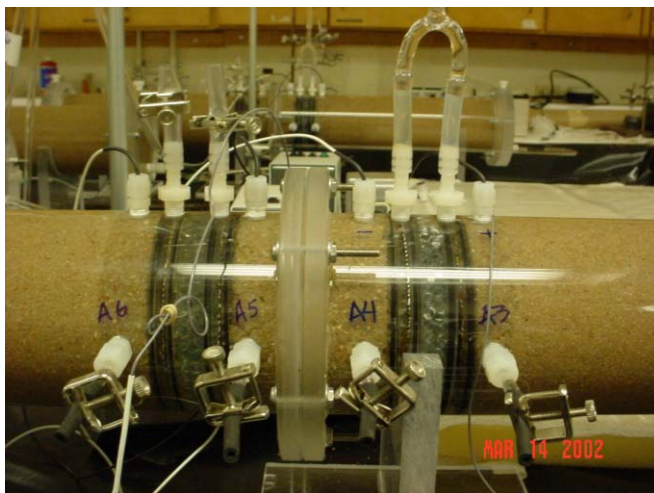
Figure 8. Column study electrode set.

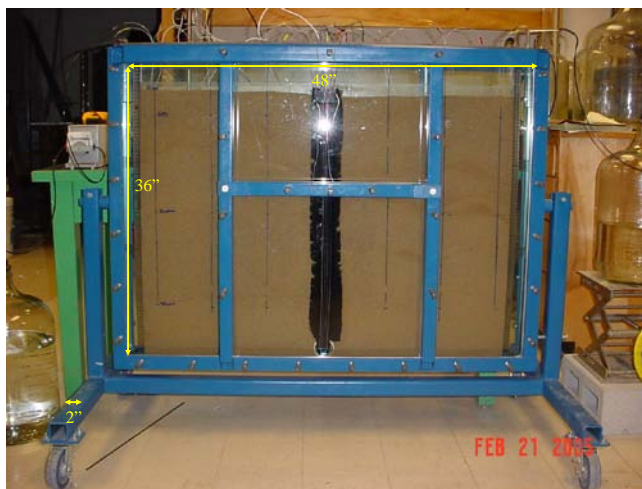
Figure 9. 2-D tank used in design testing studies.

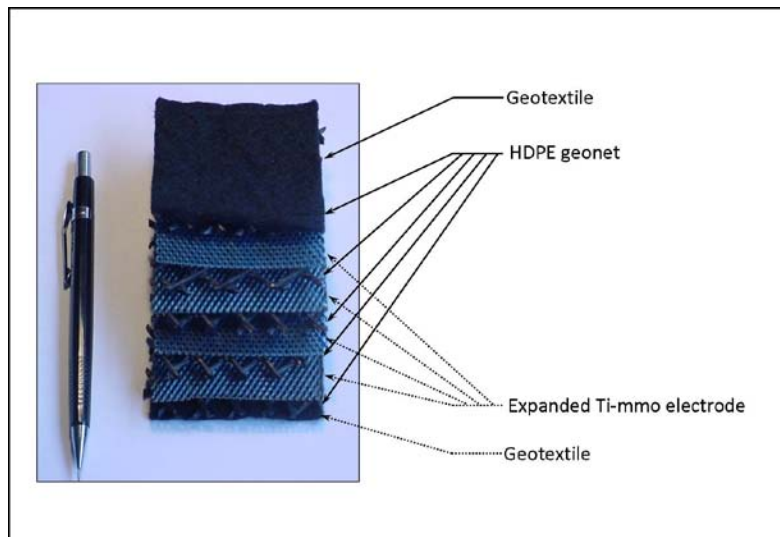
Figure 13. Composite panel components.

The primary component of the e⁻barrier is a composite panel containing four titanium mesh electrodes coated with titanium-mixed metal oxide (Ti-mmo) separated by high density polyethylene (HDPE) geonet and bounded on the outside by a geotextile. The exterior geotextile limits sediment entry into the composite panel. A photograph of the components in the composite panel is presented in Figure 13. The composite panels were mounted on vinyl sheet pile sections. Front and back views of three sheet pile sections with electrodes are shown in Figure 14.

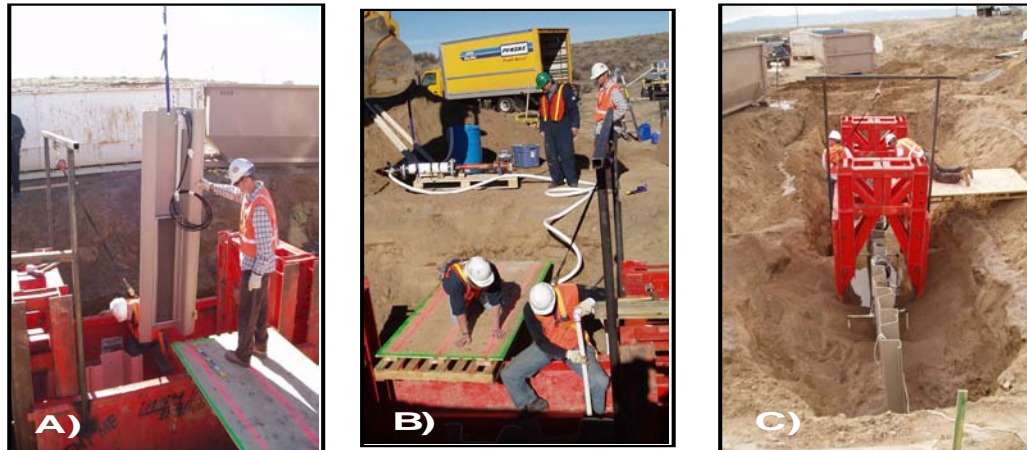
Figure 15. A) Setting the panels inside the trench box to the top of the Pierre Shale, B) emplacing a cement-bentonite seal at the base of the barrier, and C) a photo of the sheet pile prior to backfill with native sands.

A total of 15 active electrode panels were constructed. Three blank sheet pile sections were placed at each end of the barrier. The blank portions were used to tie in the bentonite wing walls in the field. The role of the bentonite wing wall was to limit flow around the e-barrier. The e-barrier was installed at PCD from January 30 through February 2, 2006 (Figure 15). As-built drawings are presented in Figure 16 and Figure 17.

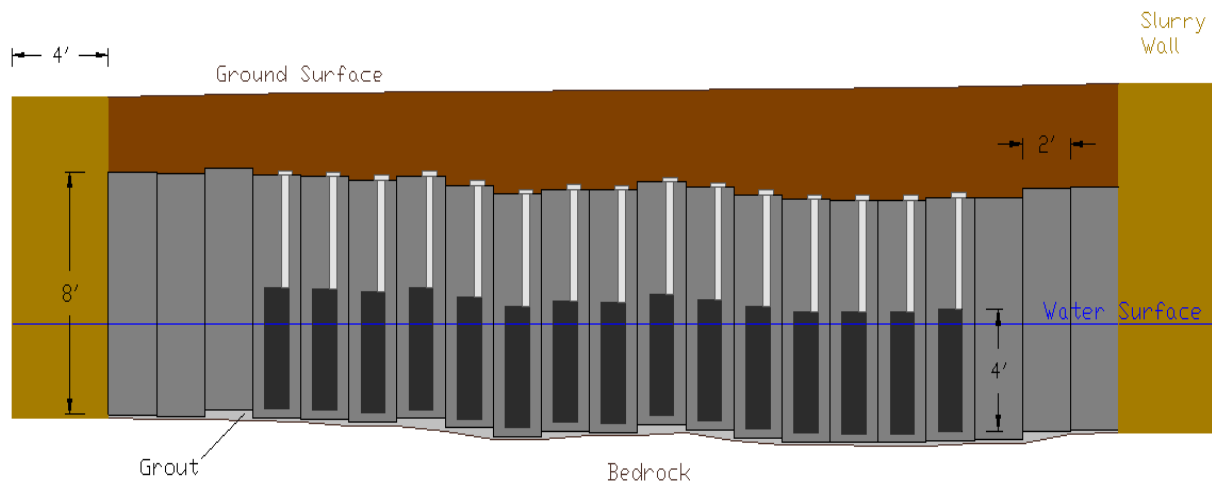
Figure 16. As-built elevation profile of e-barrier panels.

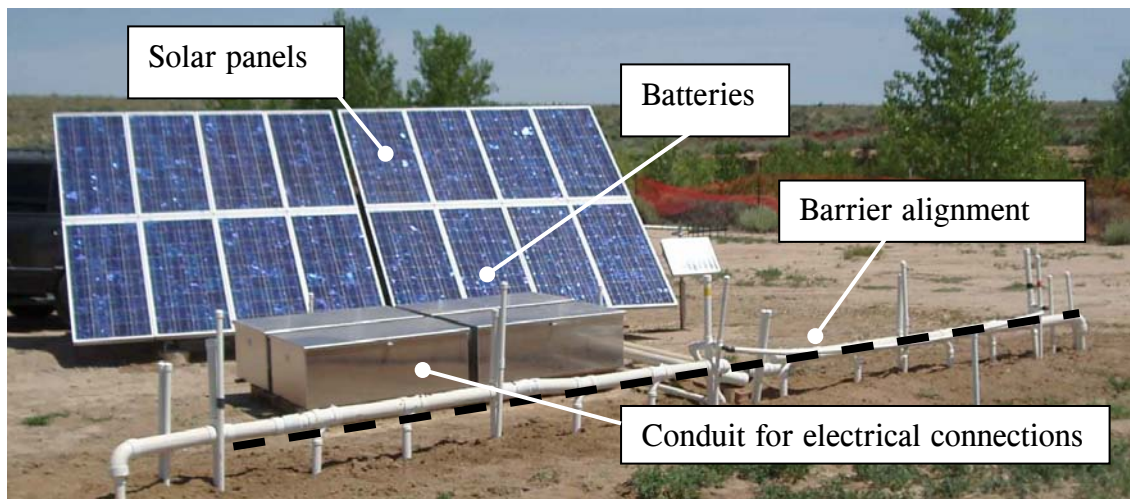
Figure 18. Solar power supply.

Treatment in the e-barrier is driven by imposing an electrical potential at the electrodes while contaminants move through the barrier via natural groundwater flow. The PCD e-barrier employed a four electrode sequence in which the primary operational mode (moving downgradient) was cathode (+), anode (-), cathode (+), and anode (-). On a daily basis, the polarity of each electrode was reversed for one hour to prevent formation of scale (inorganic precipitates) on the electrodes. Key elements of the electrical systems are shown in Figure 18 and Figure 19.

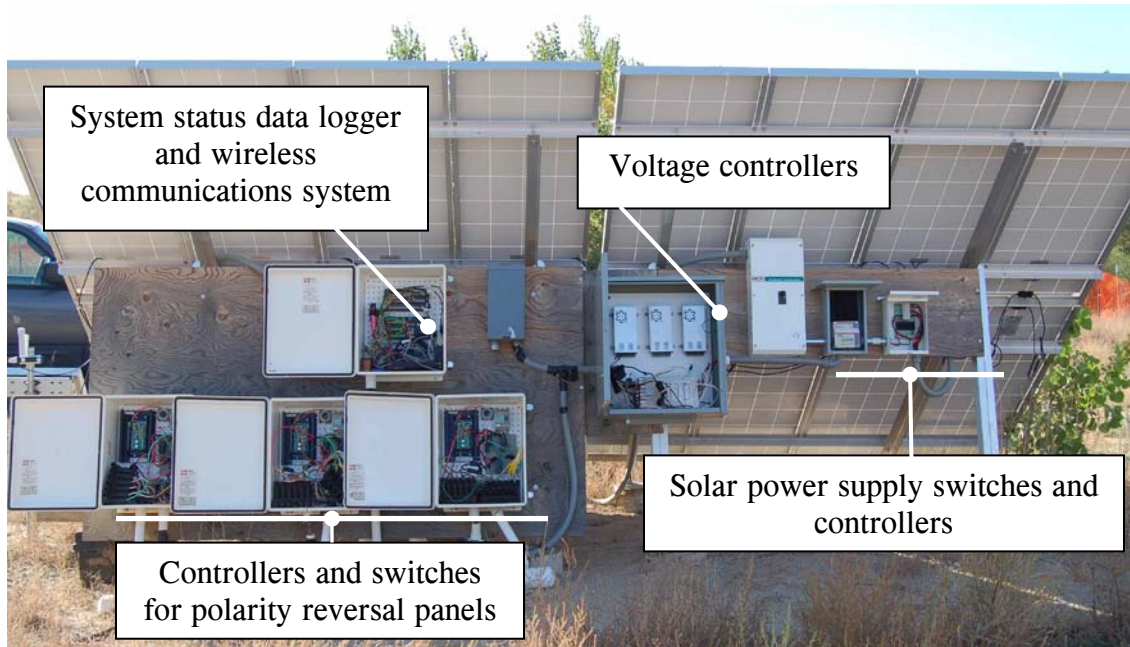
Figure 19. Electrical controllers and data logging systems.

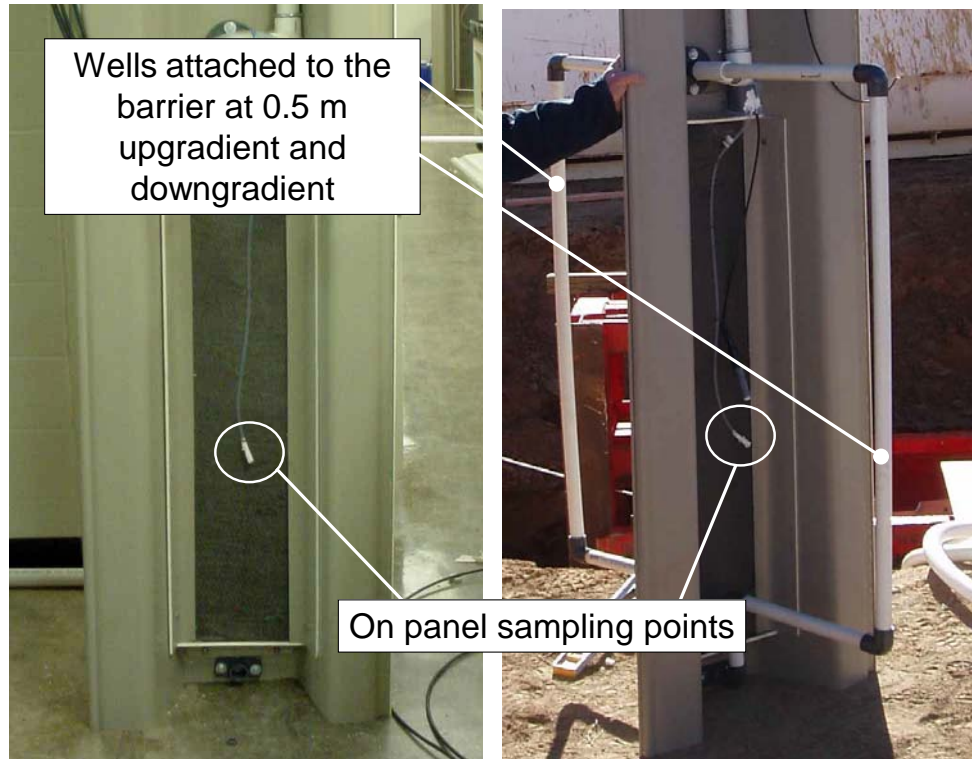
Figure 20. Water quality sampling point attached to the e-barrier.

Photos of the on-face sampling points and the 0.5 m wells (attached to the barrier) are presented in Figure 20. The sampling points on the panel face were constructed of 6.35 mm inner diameter (ID) Teflon tubing and a NytexTM cloth screen. Samples were pulled from the 0.5 m wells via a 6.35 mm ID Teflon tube. The sample points attached to the e⁻barrier panels (i.e., on-face and at 0.5 m, as shown in Figure 20) are located in backfill material. The wells at 2 and 4 m are located in the natural alluvial sands. Figure 21 illustrates the position of sampling points in cross-section and plan view.

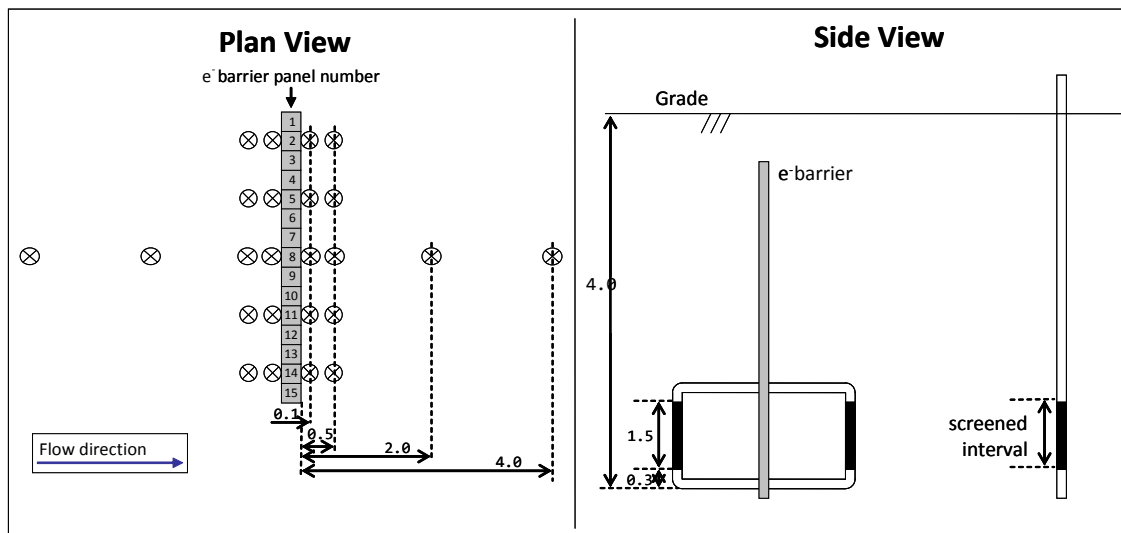
Figure 21. Network of water quality sampling points.
Distances are in meters.

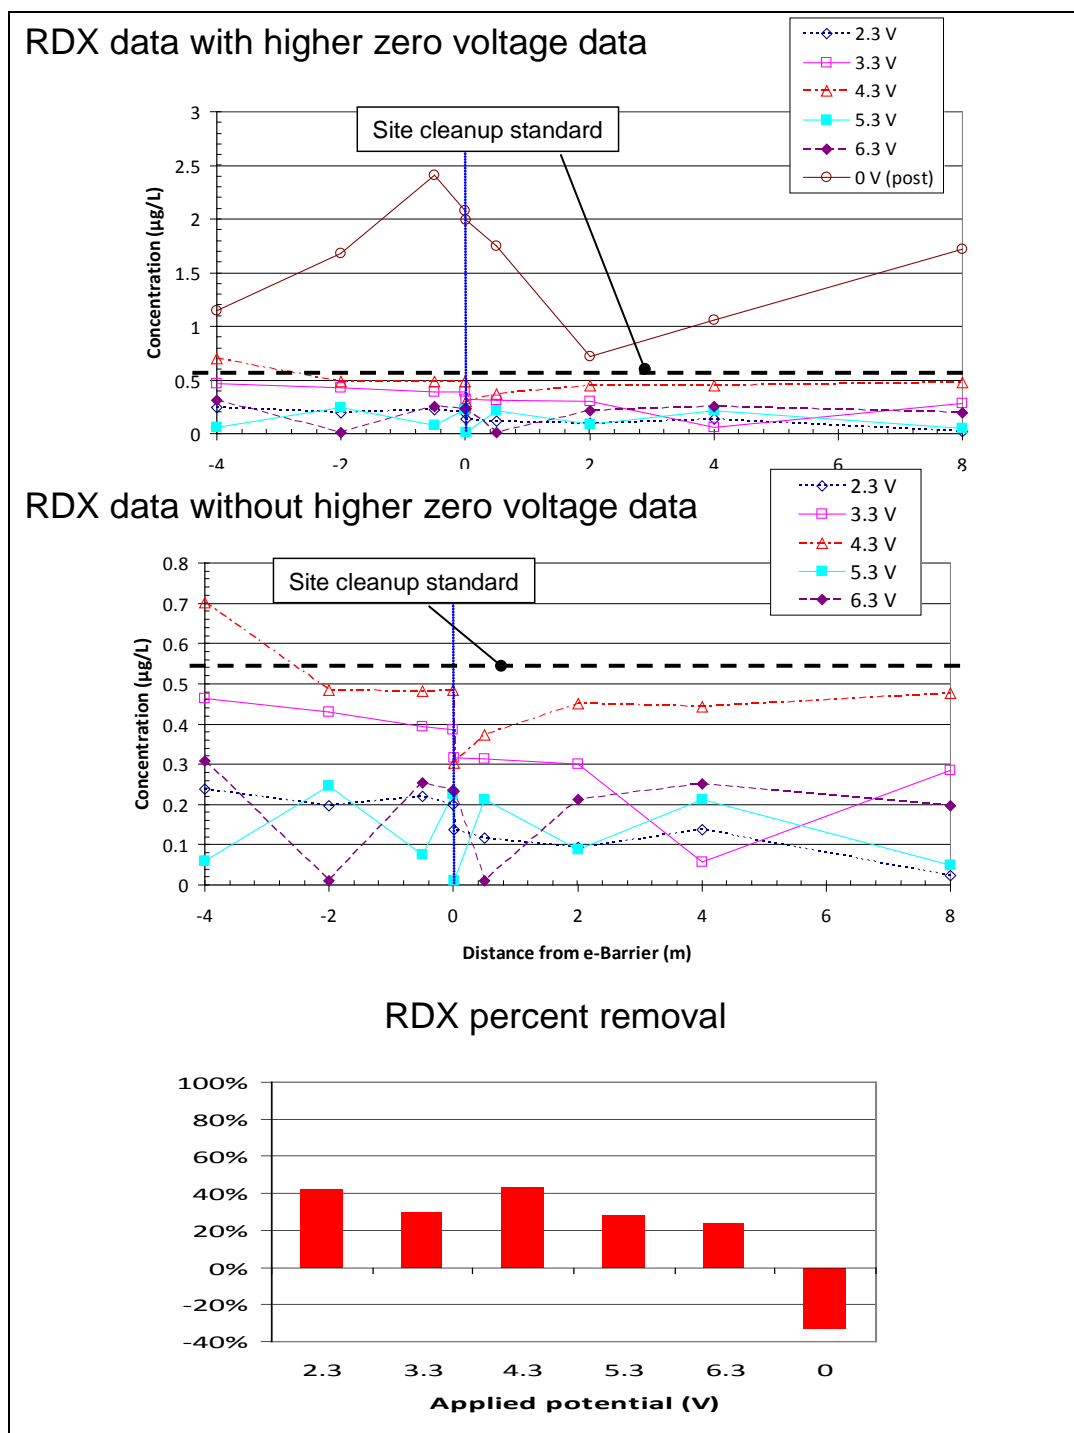
Figure 23. RDX concentration as a function of position and percent removal as a function of applied voltage.

The primary contaminant of concern at the site is RDX. The following describes the observed treatment of RDX. Figure 23 shows RDX concentrations as a function of position and percent removal for each applied voltage plus the post treatment (0 (zero) volts [0V]) condition. Concentrations of RDX range from nondetect (<0.02 µg/L) at 2 m/6.5 V to 2.4 µg/L at -0.5 m/0V. The variability of the upgradient RDX concentrations makes it difficult to rigorously resolve the performance of the e⁻barrier. On one hand, the 6.3 V RDX data everywhere is an order of magnitude lower than the post-treatment 0V data. On the other hand, the percent removal analysis suggests RDX removal in the range of 20-40%, largely independent of voltage. This compares to laboratory column study RDX removal of 99% (Section 6.3).

A curious note is that while the barrier was active, all but one data point was below the site cleanup standard of 0.55 µg/L for RDX. With the power off, all RDX concentrations are above the site cleanup standard. This raises the peculiar question of whether the e⁻barrier was having an impact on both upgradient and downgradient concentrations of RDX. This trend is also seen for HMX but not for TNT, DNT, or TNB.

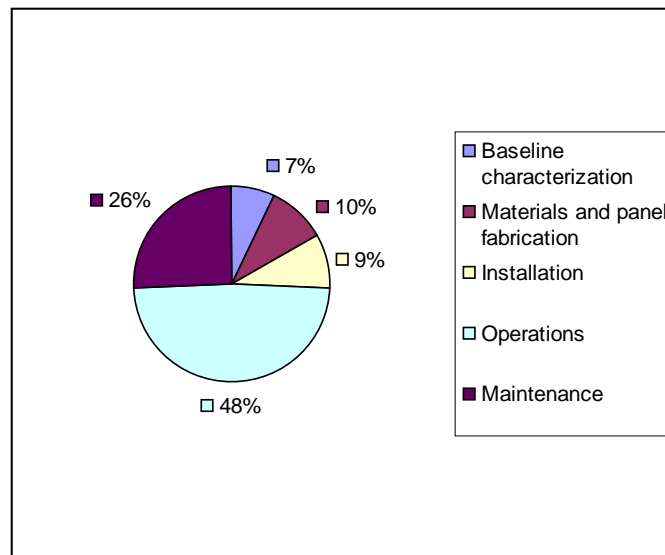
Figure 24. Distribution of life-cycle cost for a 10-year period.
(Operations and maintenance cost assumes complete replacement of all components every 10 years.)

Figure 24 presents the distribution of the life-cycle costs for a 10-year operation period for a system based on the demonstration barrier attributes. A primary assumption employed in this distribution is that operation would continue after 10 years and that the entire system would need to be replaced every 10 years. Interestingly, operations (monthly downloads of data via a wireless connection, review of monthly data, annual inspections, and annual water quality monitoring) at \$30,000/year is the largest cost. This is followed by maintenance cost (based on full replacement every 10 years) and capital cost (composed of characterization, materials, panel fabrication, and installation).
